# Manhole Inspection Summary

Manhole # S09WW\_001MH

Insp Date: **1/27/09 10:26 AM**

**Location** Address: **3407 CEDARDALE RD**

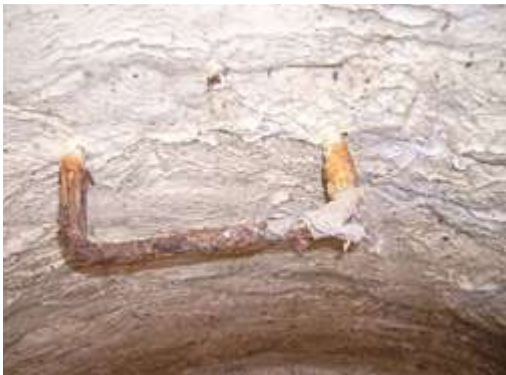
Defect 1

**Steps** Count: **3** Missing: **0** ☒ **Corroded**

**Surcharge** ☒ **Evidence Of Surcharge** Depth: **3** (ft.) ☐ Active Surcharge Present

EVIDENCE OF SURCHARGE /  
CORRODED

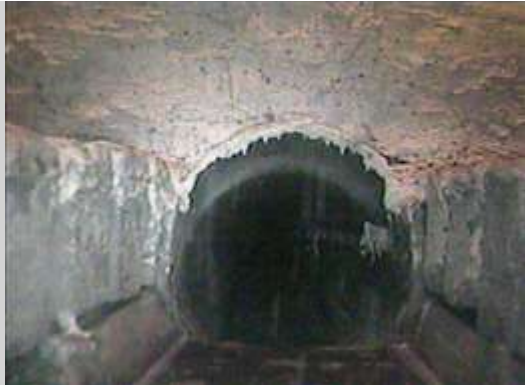
12 O'Clock Outflow

8 in. Circular Gravity Sewer  
Pipe Out @ 12 O'Clock

Infiltration: **None** Pipe Seal Cond: **Roots**

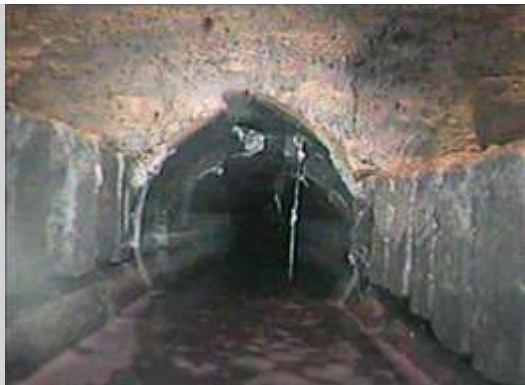
6 O'Clock Inflow

8 in. Circular Gravity Sewer  
Pipe In @ 6 O'Clock

Infiltration: **None** Pipe Seal Cond: **Sound**
